## Technical Service Bulletin

Products Affected: ASi 10, FSi 10

Description: Station Interface Card Lockup Issue

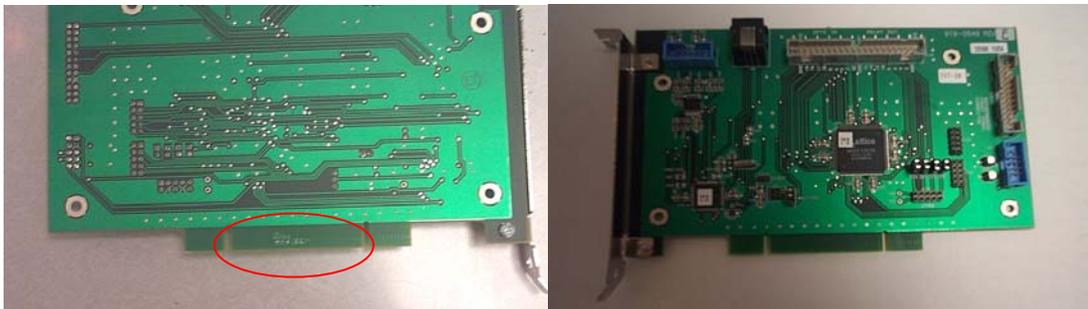
The Edge Card connector on SIC PC board (BEI part# 919-0549) is only for mechanical purposes and should not have any contacts for the PCI Buss. The PC board house put their logo on the back side of the edge card connector of SIC PC board possibly causing the PCI Buss to short. This will manifest itself with intermittent and random lockups.

Remove the SIC PC board from the unit.  
Scrap off the logo, and reinstall the board.
