## Technical Service Bulletin

Products Affected: ASi 10, FSi 10

Description: Station Interface Card Lockup Issue

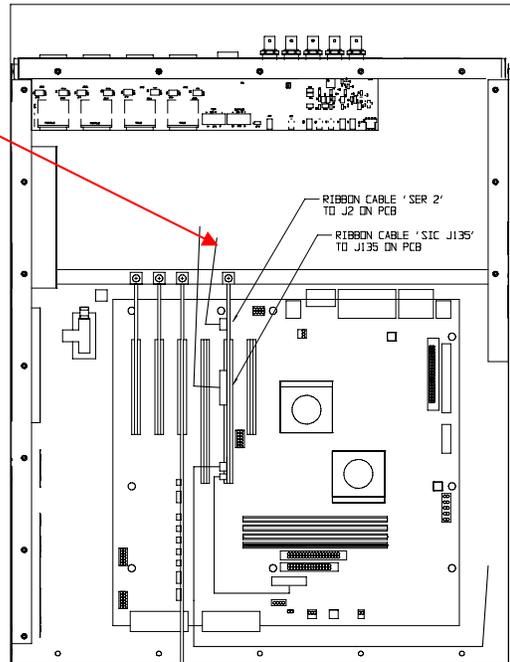
The Edge Card connector on SIC PC board (BEI part# 919-0549) is only for mechanical purposes and should not have any contacts for the PCI Buss. The PC board house put their logo on the back side of the edge card connector of SIC PC board possibly causing the PCI Buss to short. This will manifest itself with intermittent and random lockups.

Shutdown the unit and remove AC power.  
Remove top cover and locate SIC PC board.  
(BEI part# 919-0549)

Remove the SIC PC board from the unit.  
Scrap off the logo, and reinstall the board.

Replace the top cover.
