FXi 60/250 Exciter w/Exgine

Firmware Upgrade Application Guide

Updating the Exgine Card to v4.01 or Newer

597-0541-006
Revision N
February 24, 2012

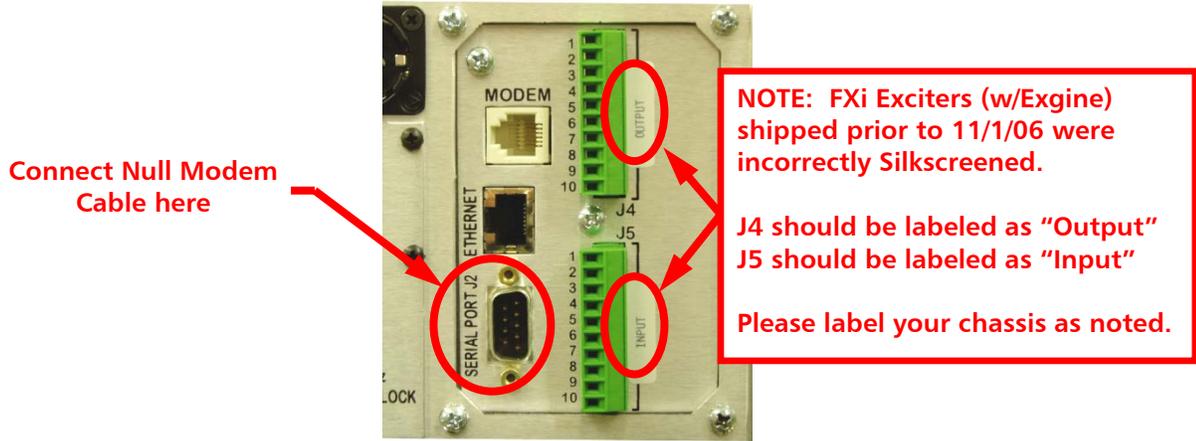
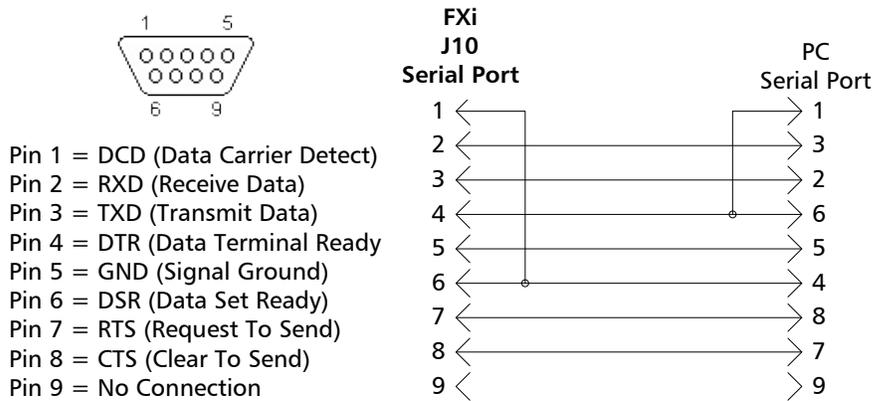
Figure 2 – Exgine Serial Port J2 / Serial Cable and Null Modem Adapter Pinouts

Step 3a – Connect a Null Modem cable (not supplied) from the Serial Port of your PC to the Exgine Serial Port J2 on the rear of the FXi.

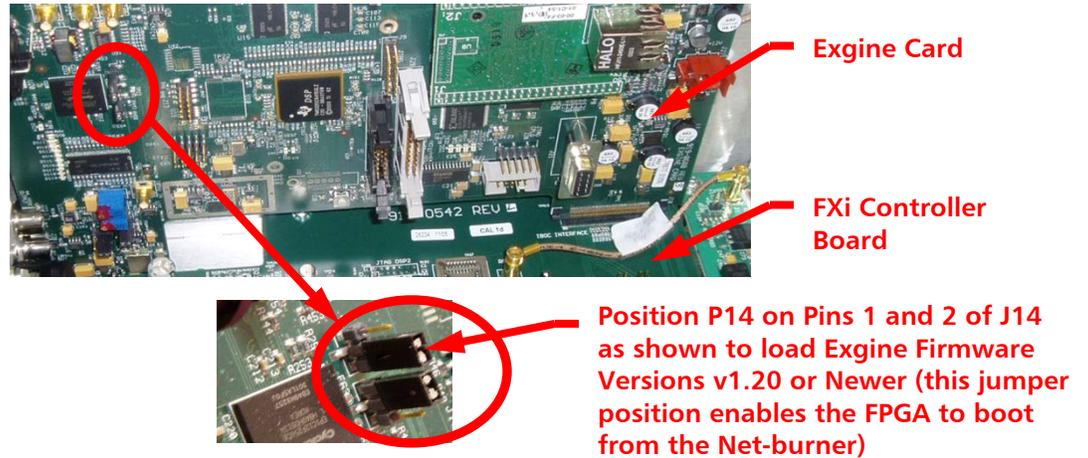
Figure 6 – Engine Card Jumper Plug P14

Step 5 – To enable the download of **Engine Firmware Versions v1.20 or Newer**, re-locate **Jumper Plug P14** to **pins 1 and 2** of **J14** on the **Engine Card** as shown below.

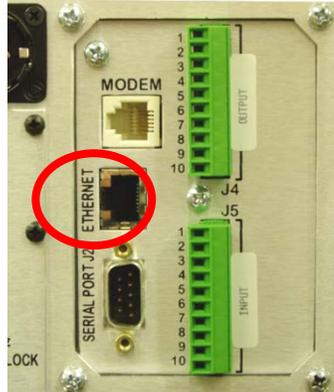
Figure 15 – Ethernet Port

Step 12 – Ensure that the FXi is ON and operational. Connect your PC to the I.P. network that the FXi is on using a Straight Through Ethernet Cable (not supplied). If you are connecting directly to the Ethernet Port on the FXi, an Ethernet Crossover Cable is required (not supplied).

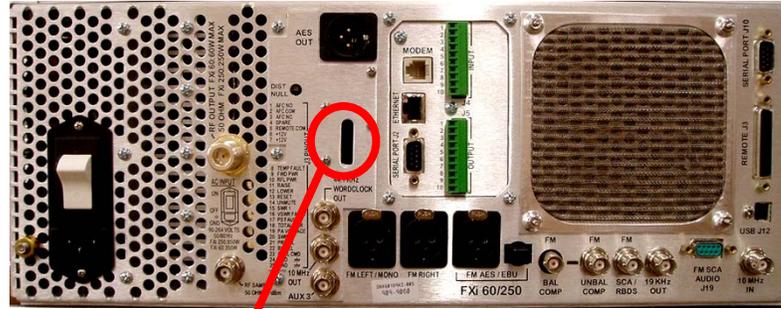
Figure 25 – Engine Status Indicator LEDs (Normal Operation)

Engine Status Indicators viewed through Slot in Cover Plate

DS24 – Normally ON (GREEN); Indicates that the FPGA has booted properly

DS11 – Normally OFF; will be ON (RED) only if an FPGA problem occurs or on initialization of system.

DS12 – Normally blinking at 0.673Hz rate. Indicates LVDS DMA is running.

DS17 – Normally ON (BLUE) when the 10 MHz reference signal is locked to the 0.673 Hz Ethernet Data Packet Rate. (will be OFF after Power Up until lock occurs) 8-12 hours after power up

DS6 – Normally ON (Green) after HD carriers are being output.

DS13 – Normally ON (GREEN); after synchronization.

DS14 – Normally Blinking ON / OFF (GREEN) indicating Ethernet Data Packets are being processed. Also ON when NIOS Firmware is loaded into FPGA.

DS15 – Normally ON (GREEN)

DS16 – Normally ON (GREEN); Off indicates no Ethernet data packages arriving

DS18 – Normally Blinking ON / OFF (BLUE) indicating that the 0.673 Hz Ethernet Packet Rate Signal is present

DS19 – Normally Blinking ON / OFF (BLUE) indicating that the on board 10 MHz Reference Signal is present

NOTE: DS18 & DS19 – Will be Blinking ON / OFF Simultaneously

Step 23 – To ensure that the firmware load was in fact successful, check the Exgine Status Indicator LEDs for normal operation as shown below.

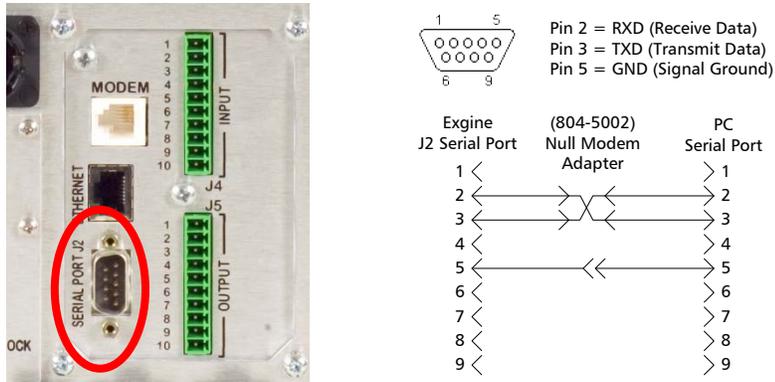
Figure 27 – Engine Serial Port J2 / Serial Cable and Null Modem Adapter Pinouts

Step 3a – Connect a Null Modem cable (not supplied) from the Serial Port of your PC to the Engine Serial Port J2 on the rear of the FXi.

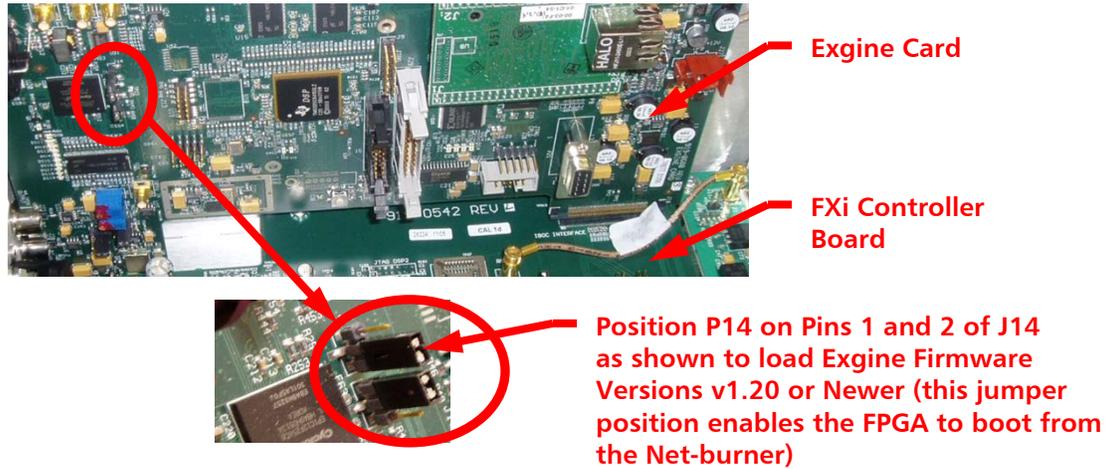
Figure 30 – Exgine Card Jumper Plug P14

Step 5 – To enable the download of **Exgine Firmware Versions v1.20 or Newer**, re-locate **Jumper Plug P14** to **pins 1 and 2** of **J14** on the **Exgine Card** as shown below.

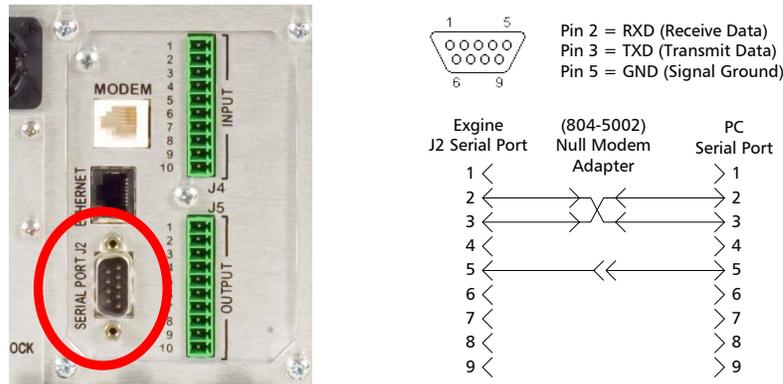
Figure 31 – Exgine Serial Port J2 / Serial Cable and Null Modem Adapter Pinouts

Step 8 – Ensure that the FXi Exciter is ON and Operational. Connect a Null Modem Cable (not supplied) to the **Exgine Serial Port J2** on the rear of the FXi Exciter and then to the Serial Port on a Personal Computer.

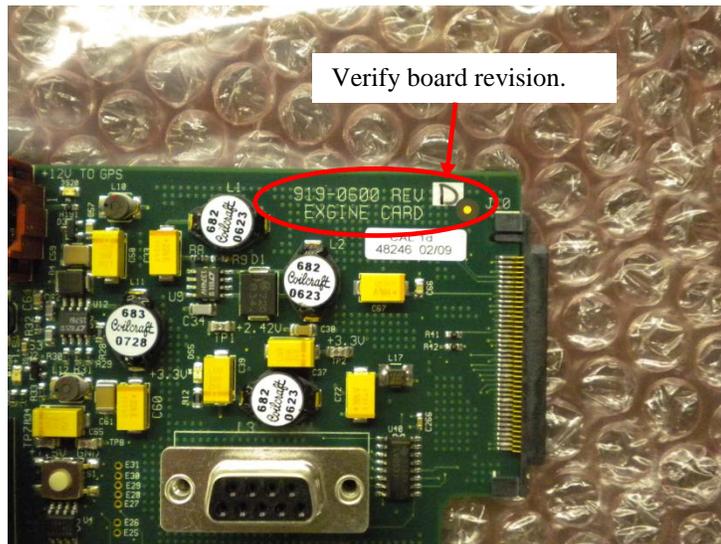
If this upgrade does not work with either fpga selection, remove the lid of the FXi and verify the board revision. The figure below illustrates a Rev D board. This fpga firmware may not work on early revision A boards.

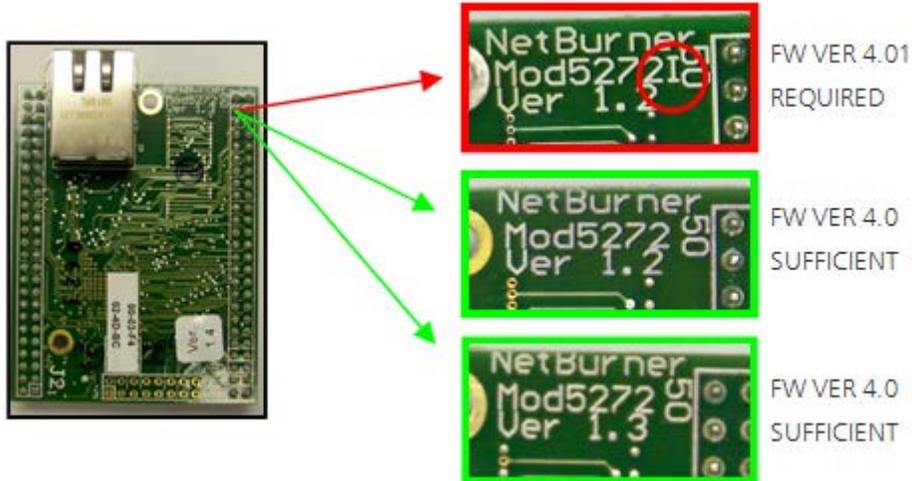
If you have experienced this issue, please inspect the hardware version of the IP interface Netburner card. If the hardware is Mod5272I Ver 1.2, the Engine card firmware must be upgraded to version 4.01 or greater. Note: Mod5272 Ver 1.2 or Ver 1.3 cards (without the I) will operate properly with Engine card firmware Ver 4.0.
